PREPARATION PAYS OFF DURING A FLOOD EVENT

UNDERSTANDING SITE CONDITIONS AND CUSTOMER
CONCERNS RESULTS IN RELIABLE SITE ACCESS

**Sterling uses concrete barriers
to mitigate risk in flood plain**

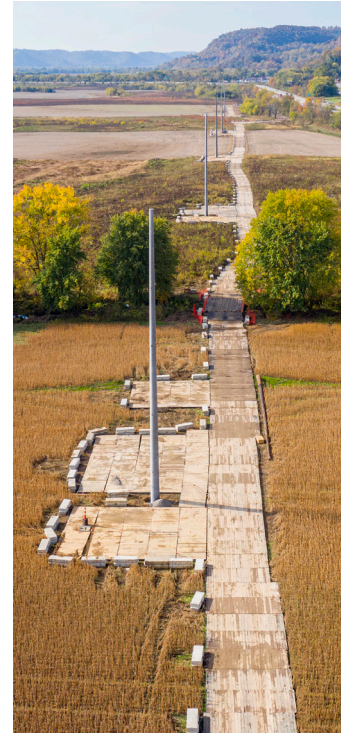
A catastrophic flooding event would cause costly delays and safety hazards if the site access was damaged or washed away. To mitigate that risk, Sterling connected 4,000 mats TerraLam CLT mats and timber mats to 2,500 concrete jersey barriers along the ROW.

Between Christmas and the end of the year, that preparation paid off. The Ohio River rapidly rose 17 feet in about 12 hours, dramatically flooding the job site. Because Sterling proactively installed and maintained mitigations like the concrete barriers and connection straps, no matting or bridges were lost during the flooding event.
