ELIMINATING STANDING WATER CHALLENGES

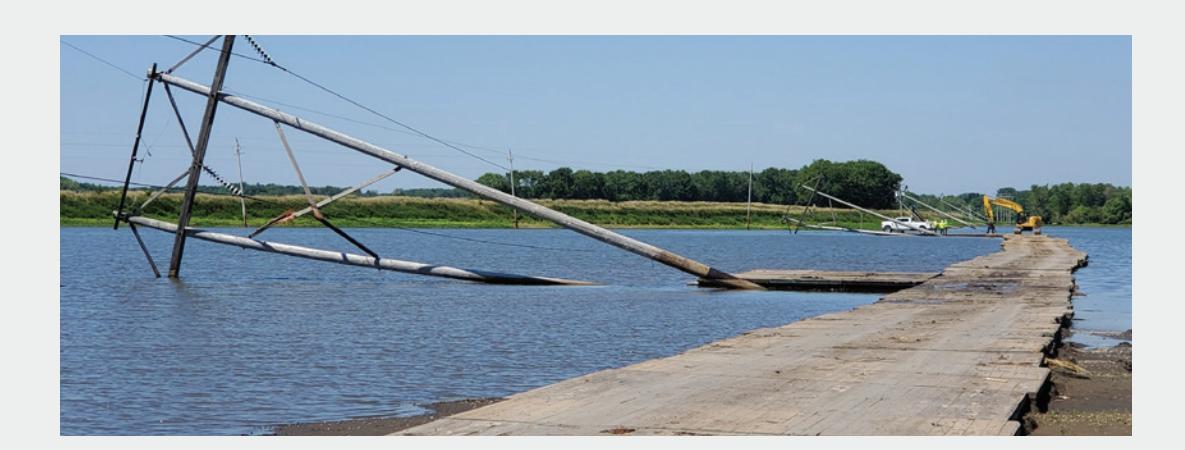
A combination of timber and TerraLam[®] 508 mats raised the work area quickly and safely.

To raise the work area above the standing water line, Sterling used a combination of traditional timber mats as a base and decked it with Sterling's wider TerraLam[®] 508 mats to keep large, heavy equipment up and out of the water. A total of 2,755 mats were used, including 1,446 TerraLam[®] 508 mats. The Sterling team also installed a stacked runner system capped with laminate mats for approximately 7,000 linear feet and installed six 100' x 100' work pads to stabilize the repair area.
