LEAPFROGGING ACROSS MILES OF SATURATED GROUND

COST-SAVING APPLICATION OF CONSTRUCTION MATS IMPROVES ACCESS AND EFFICIENCY

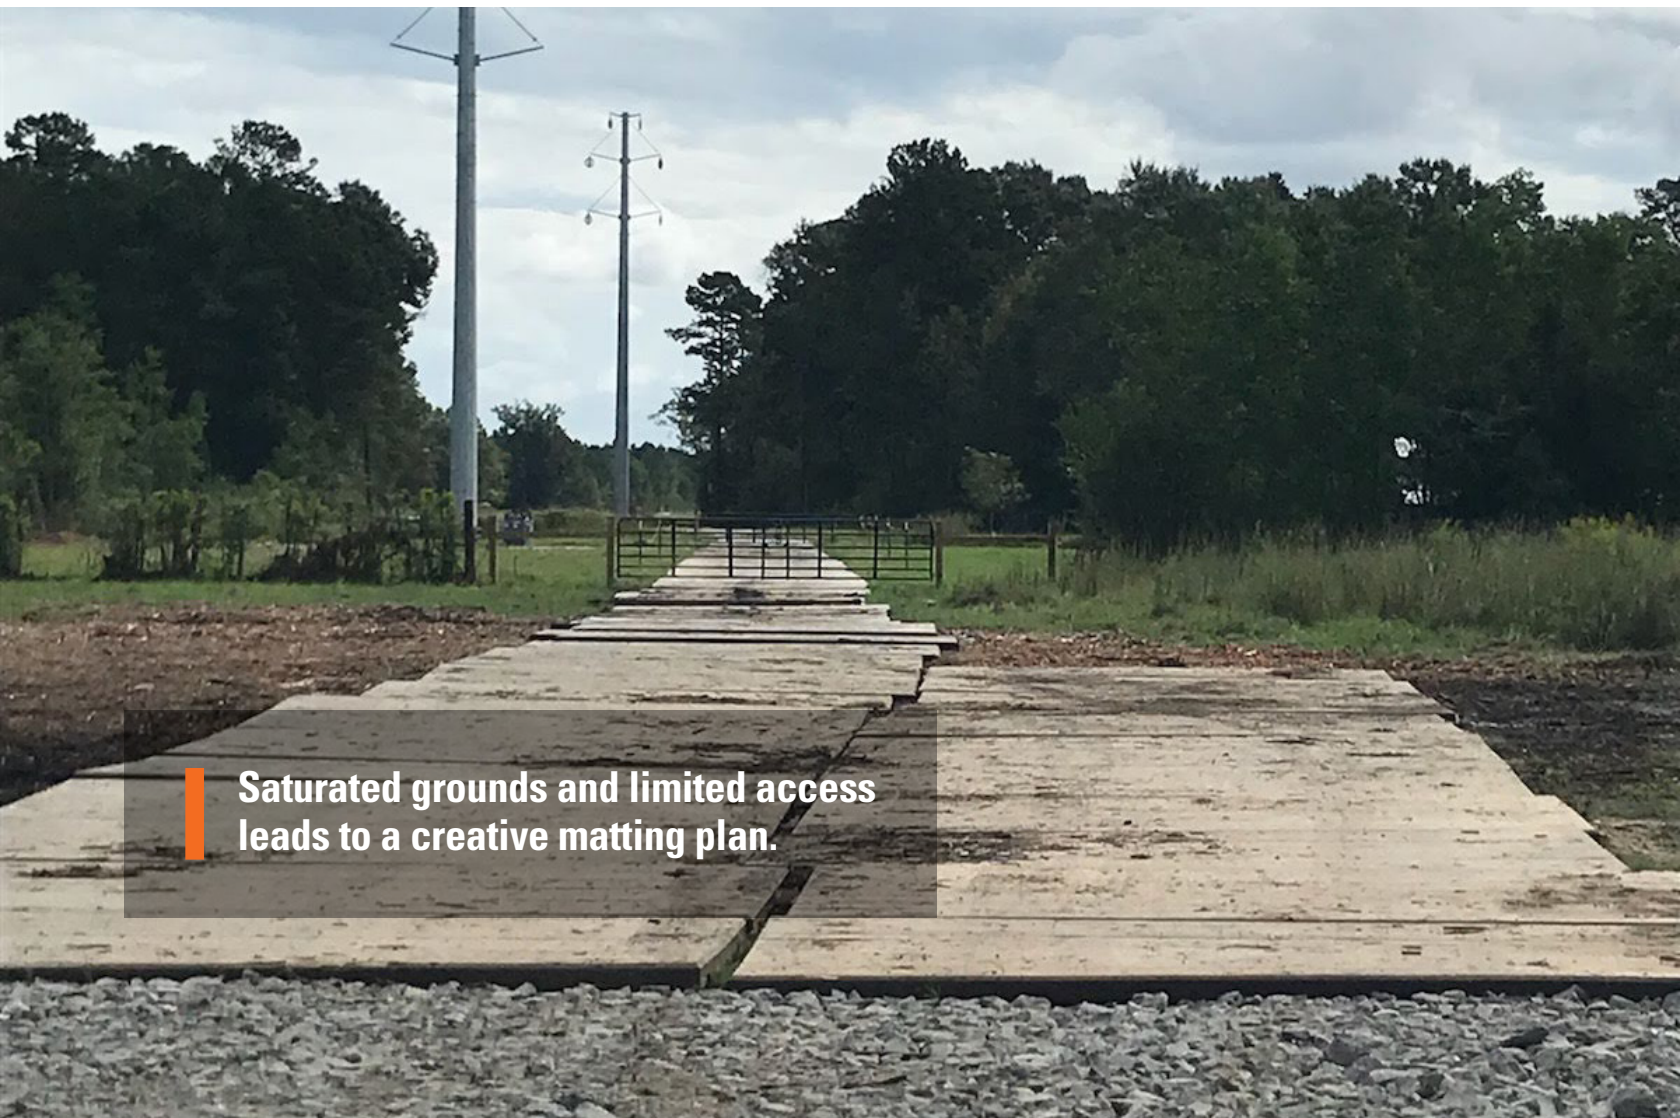
Saturated grounds and limited access leads to a creative matting plan.
