GETTING TONS OF ROCK TO DAMAGED LEVEES

DURABLE, DEPENDABLE CONSTRUCTION MATS ARE CRITICAL TO PROJECT SUCCESS

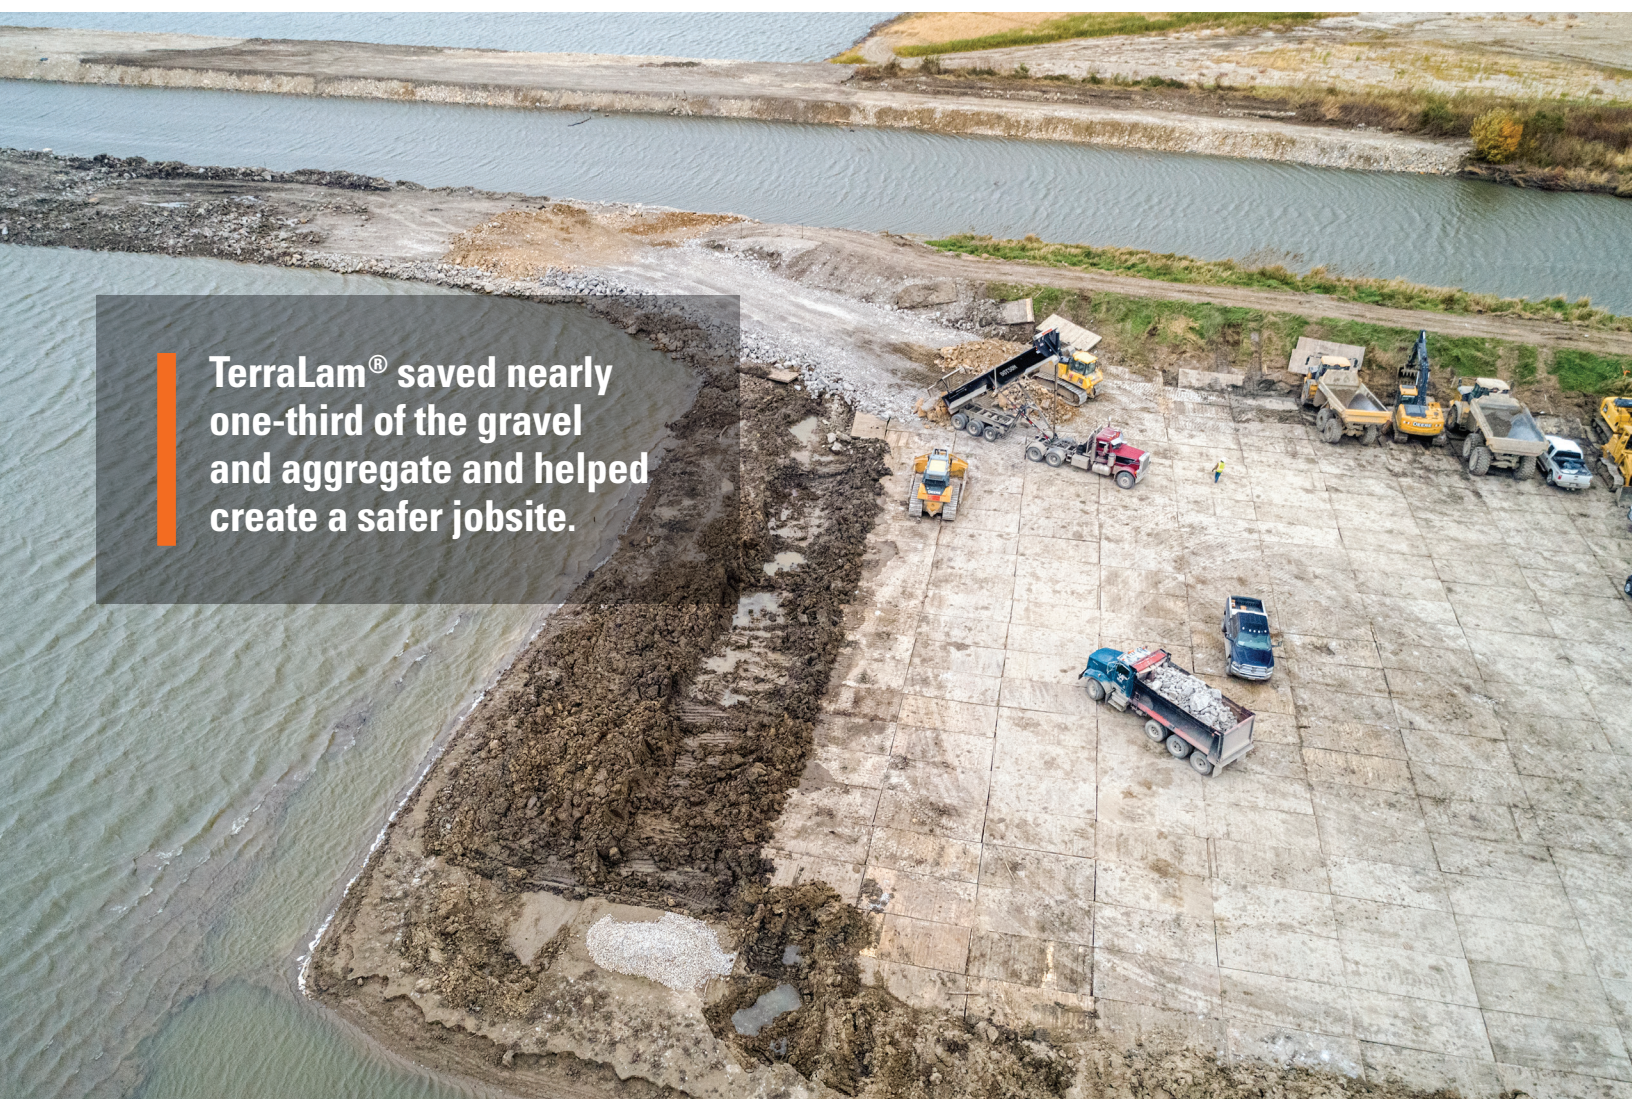
TerraLam[®] saved nearly one-third of the gravel and aggregate and helped create a safer jobsite.

By working closely with the client and conducting onsite research, the Sterling team determined that the TerraLam CLT mats would provide the stable roadway and work pads required to deliver the massive volume of rock needed to rebuild the levee system. In addition to their durability, TerraLam mats are constructed as a single, solid mat with no gaps between the overlapping timber layers. This reduces water and mud from hydraulically pumping onto the temporary work surfaces, which in turn prevents fall hazards for crews and rubber-tire equipment slide offs.

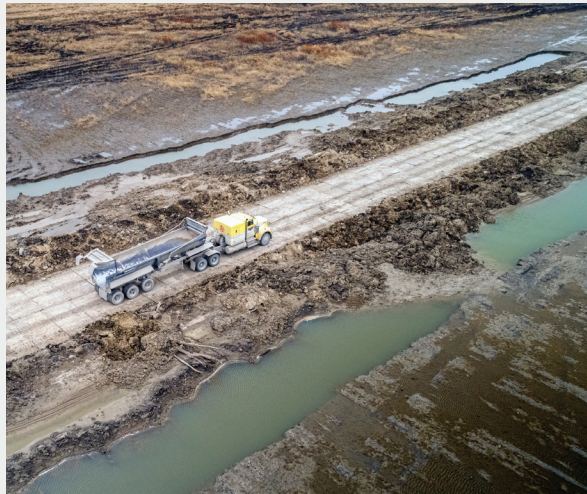
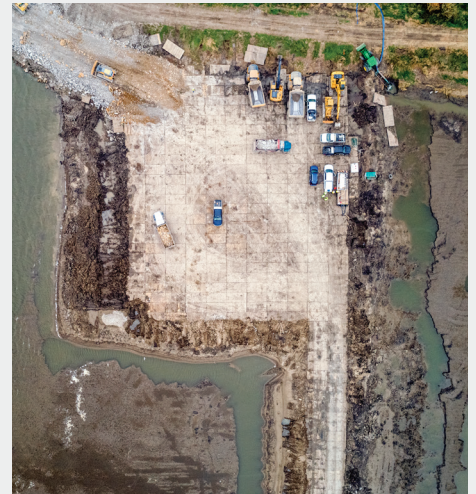
Among the TerraLam CLT options, the TerraLam® 508 mat was selected because of its thickness and exceptional durability in this application. Because soil conditions were less than favorable, a thicker mat was required to

create stable roadways and work platforms that wouldn't be compromised by deep mud — which can be a serious problem with traditional bolted access mats. In fact, to offset this disparity, over 5,000 bolted access mats would have been required to complete the project. But with the TerraLam® 508 mat, only 2,300 mats were used. TerraLam mats also reduced the number of loads needed to ship the mats in and out of the job site by 50 percent, which in turn cut overall delivery and installation time by nearly half.
